INACTIVE AND ABANDONED MINE LANDS— New Light and Mammoth Mines, Slate Creek Mining District, Whatcom County, Washington

Open File Report 2003-13
July 2003

Inactive and Abandoned Mine Lands—New Light and Mammoth Mines, Slate Creek Mining District, Whatcom County, Washington

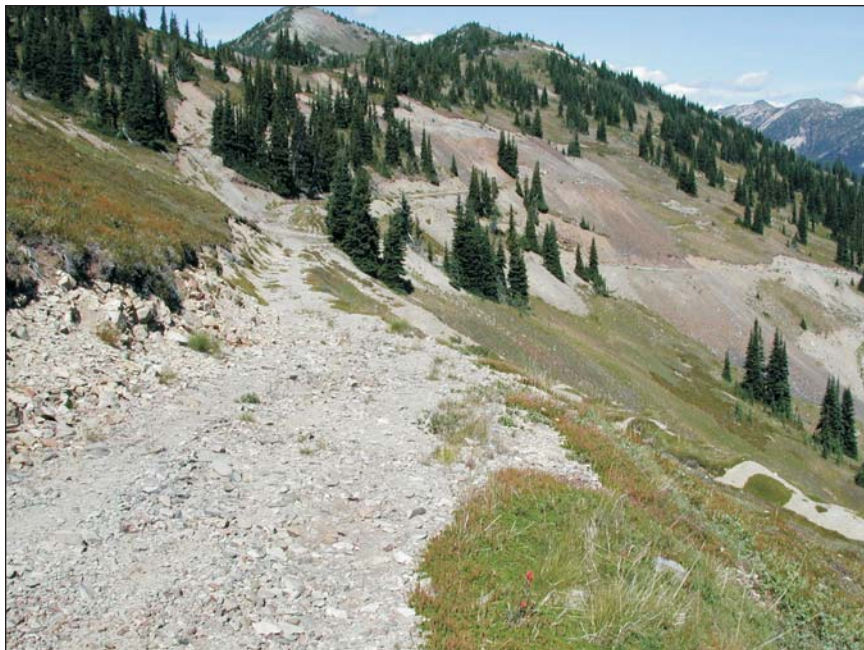
Figure 3. Overview of the New Light mine excavations. The glory hole and open pit are in the upper left near the ridge. View to the north.

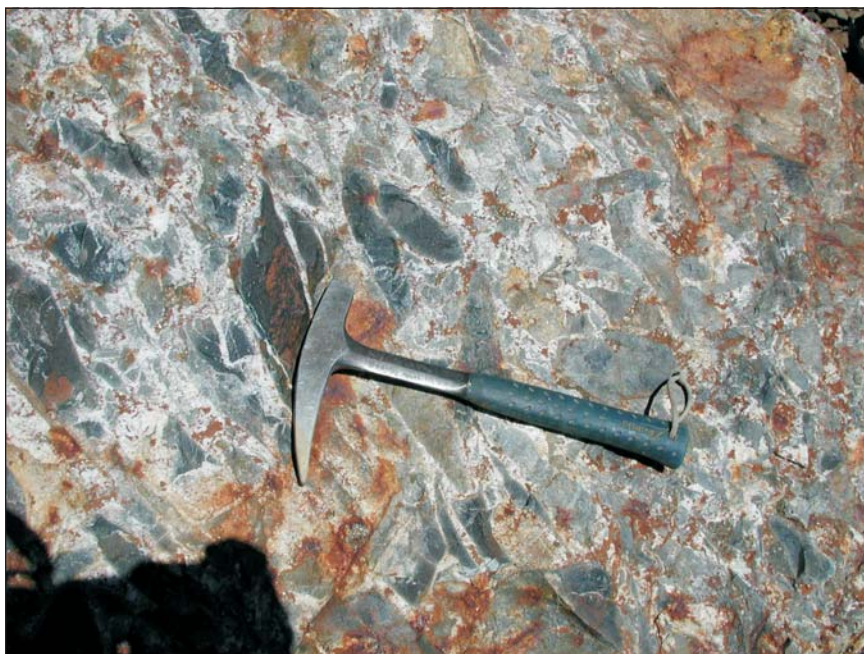
Figure 4. Quartz-cemented breccia in the New Light open pit. Hammer for scale.

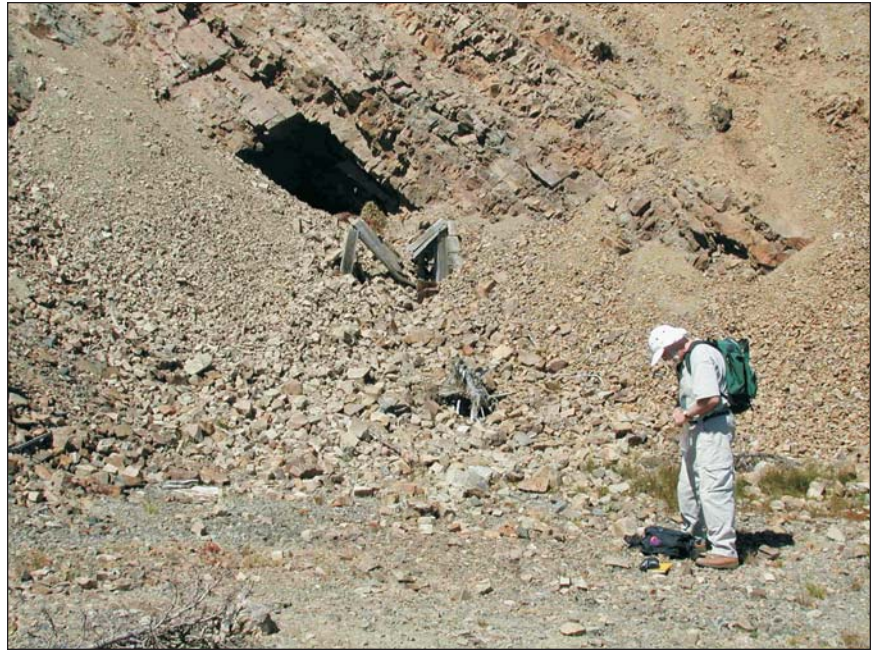
The New Light mine ultimately consisted of six horizontal adits; in descending order by elevation, they are: adit 1 (Fig. 5), adit 2, Aleen tunnel, Triangle tunnel, adit 3, and adit 4. When we did our field work August of 2001, all of the openings were caved at the entrance or a short distance inside. A glory hole (Fig. 6) with near-vertical walls and open pit (Fig. 7) were excavated in the brecciated zone at the mine's highest elevation near point 6835

Figure 5. Adit 1 portal at the New Light mine. View to the northwest.

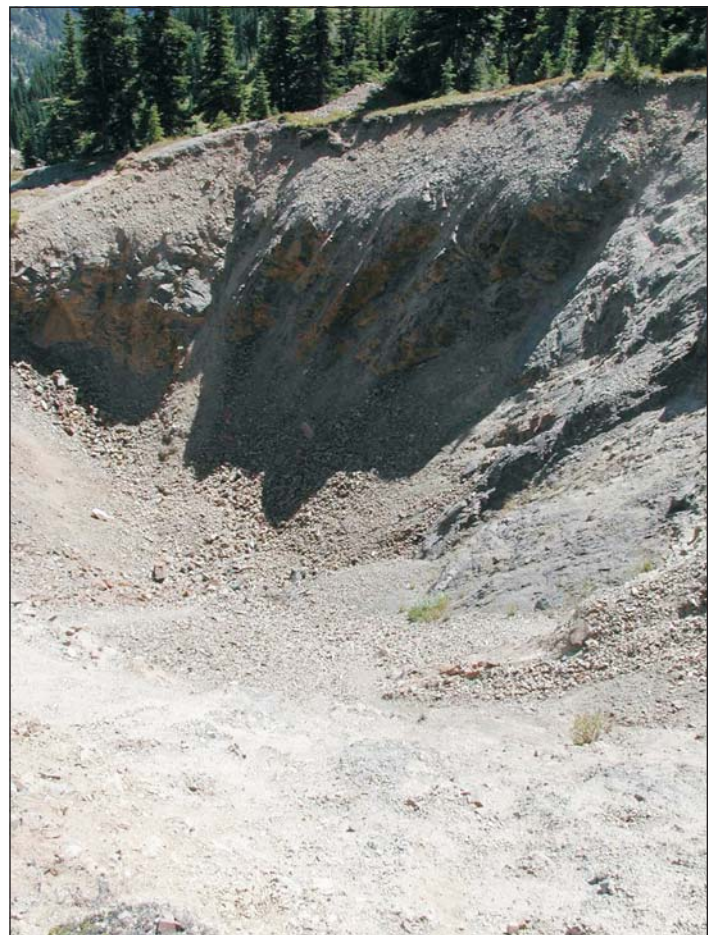
Figure 6. New Light glory hole. View to the south.

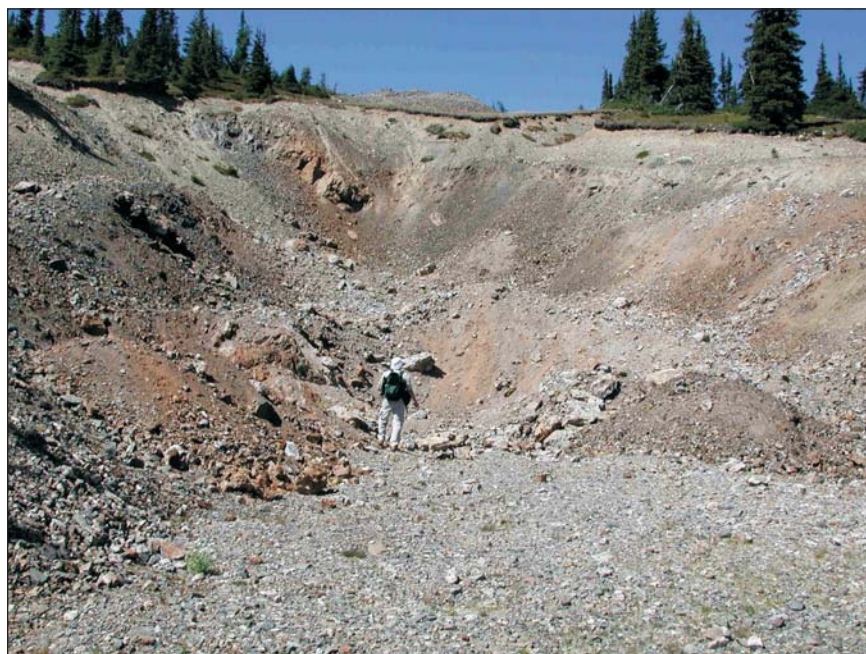
Waste rock dumps adjacent to adits at the New Light are typically less than 500 cubic yards. The open pit floor is a massive jumble of broken rock. The Mammoth 'D' tunnel dump is com-

Figure 7. New Light open pit excavation. View to the north.

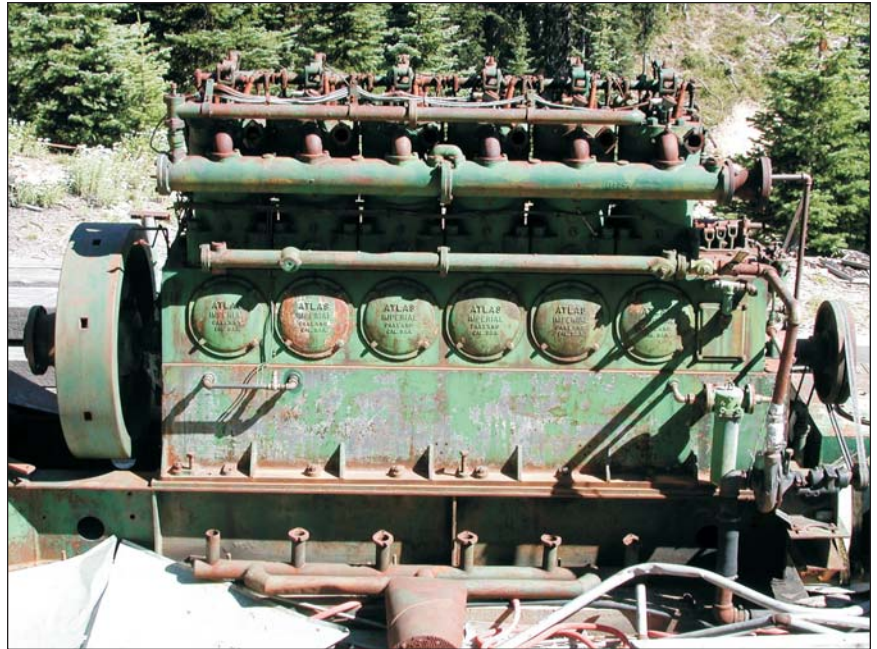
Figure 9. 220-horsepower Atlas diesel engine at the New Light mill site.

Machinery: A 6-cylinder, 220-horsepower Atlas diesel still occupies its former foundation at the New Light mill site. An oil reservoir is attached. It originally powered a 187-kilovolt Westinghouse alternating current generator, which is no longer there.

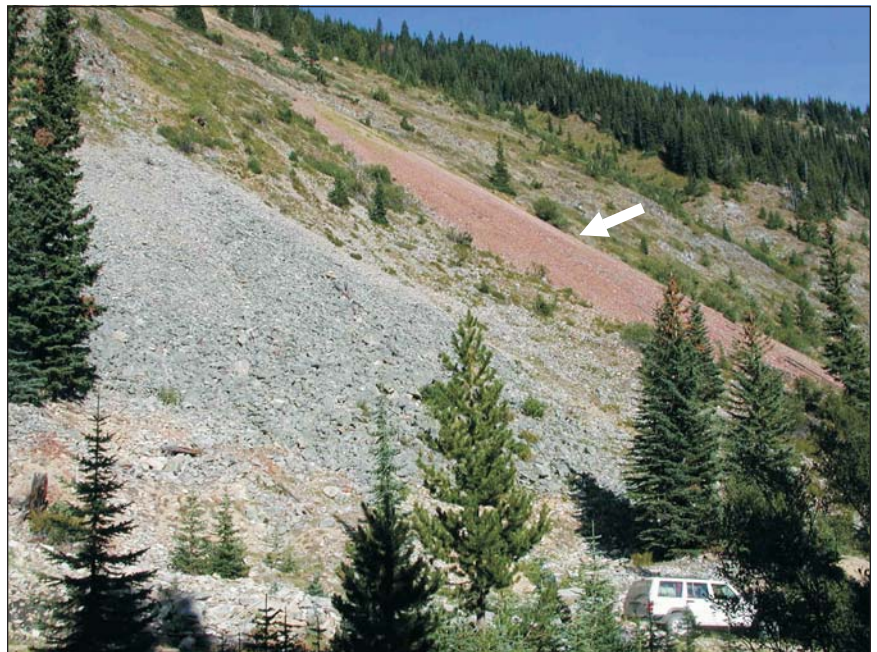
posed of unmineralized quartzite shotrock. We did not examine the upper Mammoth tunnel dump.

Figure 10. Mammoth mine waste rock dump (arrow). View to the east.

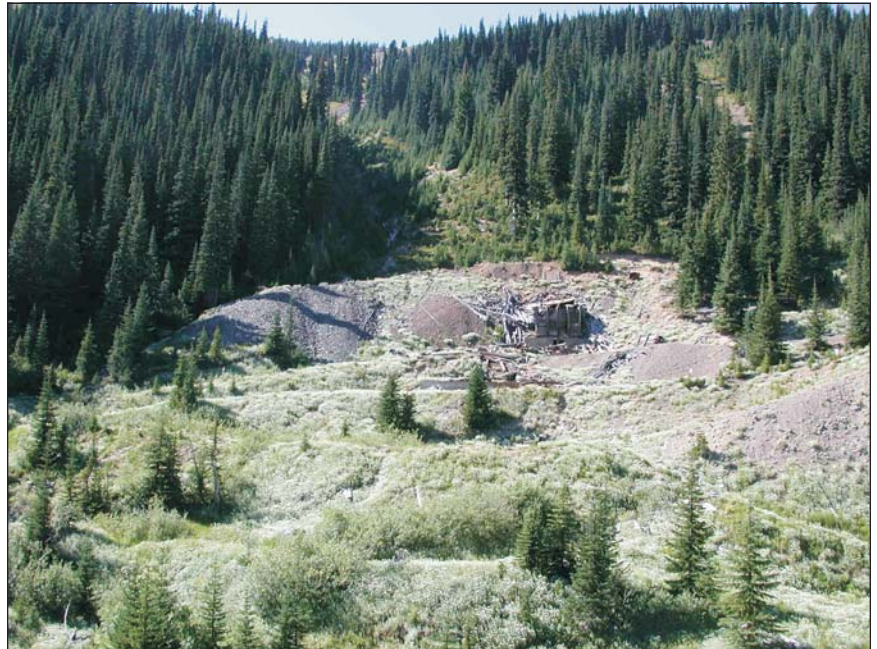
Reclamation activity: Natural vegetation has overtaken almost all the New Light mill tailings area. The mine dumps are barren.

**Figure 11.** Overview of New Light mill site. Revegetated tailings in the foreground terraces.**Table 6.** Surface water field data. ---, no data; *, data collected by Robert L. Raforth, Washington Department of Ecology, Water Quality Division; low flow, Aug. 2001; high flow, June 2001 (Raforth and others, 2002); **, numbered photos online at <http://www.dnr.wa.gov/geology/iaml/03-13/>

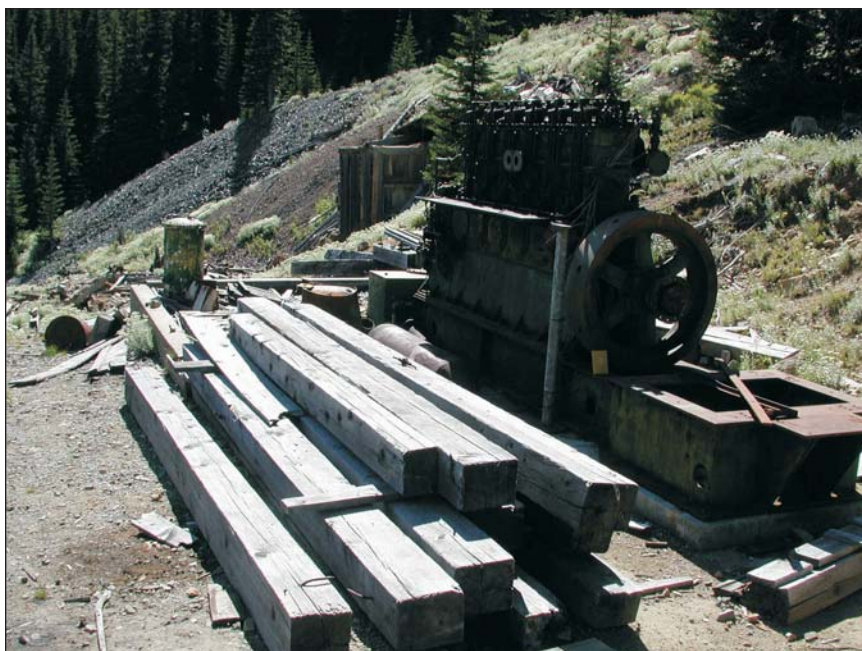
Materials: Several hundred feet of pipe are on the dump at New Light adit 2. At the mill site, we found two 55-gallon drums of unknown material and 10 pieces of about 8 inch x 10 inch x 14 foot timbers (Fig. 12). Mammoth had none.

Figure 12. Timbers and 55-gallon drums at New Light mill.
